# **GREEN AUDIT AND QUALITY AUDIT REPORT**

WATER AUDIT, ENERGY AUDIT,

# **NEW HORIZON COLLEGE OF ENGINEERING**

# 5. ENERGY AUDIT

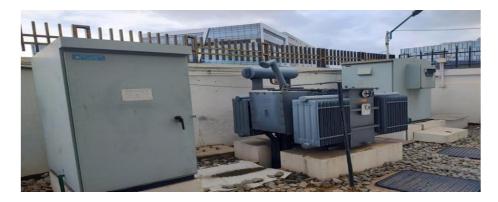
Figure 5-1: Transformer unit Installed in the campus

Incoming power supply from BESCOM is received at the transformer yard inside the college premises. The 11 kV rated HT power supply is stepped down to LT 433V, by one number of 500 kVA rated transformer. Transformer unit installed inside college premises is as shown in the figure 5-1.

C	
S. No.	Description	Units	Details
1	Rated Capacity	kVA	500
2	Rated Voltage Prim/Sec	kV	11/0.433
3	Rated Current Prim/Sec	А	2.6-24/6.66-64
4	Type of Cooling	-	ONAN
5	Frequency	Hz	50
6	Impedance	-	4.48%

S. No.	Description	Units	Details
7	Phase	-	3
8	Make	-	Kiran Power Rectification Services (P) Ltd. (KPRS)

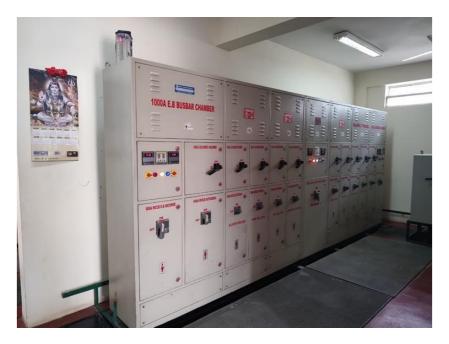
Figure 5-2: Electrical panel Room

The LT supply from the transformer is taken to the main distribution panel located inside the Electrical panel room near the transformer yard. Electrical panel room is as shown in the figure 5-2. One number of 400 kVAr rated capacitor bank have been installed at the main incomer panel for power factor improvement.

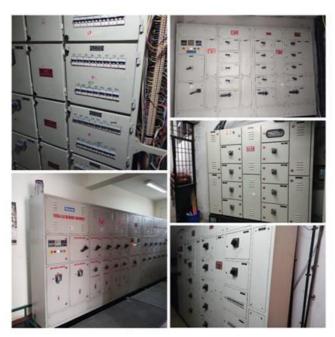
Figure 5-5: Electrical distribution panels in various blocks

Power supply cables from the electrical panel room is distributed to the various distribuition panels placed inside the blocks. From the main LT sub-station panel room, power supply is catered to individual blocks. There is an feeder pillar installed near the NSB block. From this feedar pillar the power is supplied to SVP block, NSB block, RC block and JKR block. For all the other remaining blocks, the power is supplied directly from the LT sub-station panel room. Figure 5.4 shows the feeder pillar near the NSB block. The electrical panels located in various blocks sample pictures are given in figure 5.5.

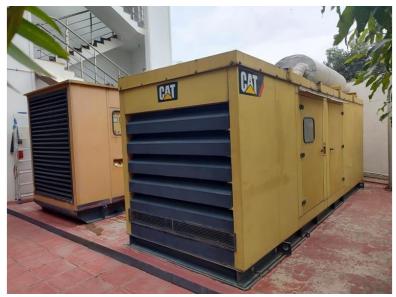
Figure 5-6: Diesel Generator (DG) sets

Two numbers of DG (Diesel Generator) sets are used for backup power supply, during power failure from BESCOM. DG set installed at the college premises is shown in the figure 5-6. The name plate specification rating of the DG set is shown in the table 5-2.

S. No.	Description	Unit	DG # 1	DG # 2
1	Rated Capacity	kVA	500	250
2	Rated voltage	Volts	415	415
3	Rated current	Ampere	696	347.8
4	Frequency	Hz	50	50
5	Power factor	-	0.80	0.80
6	Rated Demand	kVA	500	250
7	Rated Power	kW	400	200
8	Make	-	Caterpillar	Leroy Somer

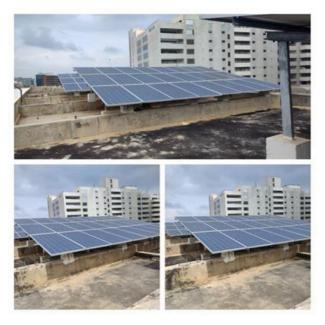
Figure 5-8: Solar rooftop PV system installed in SVP block

SRTPV (Solar Roof Top Photo Voltaic) system was installed at the terrace of SVP (Mechanical) block and in NSB block. The capacity of SRTPV installed in SVP block is of **25 kWp** rated and the capacity of SRTPV installed in NSB block is of **5 kWp** rated.

The SRTPV is off-grid system type with battery backup. During the audit, photo of SRTPV systems are collected and is shown in figure 5-8 and figure 5-9.

The solar power generated from **25 kWp** system installed in the SVP block is consumed by the electrical loads in the SVP block only. The 5 **kWp** system installed in NSB block supplies power to NSB block lighting loads.

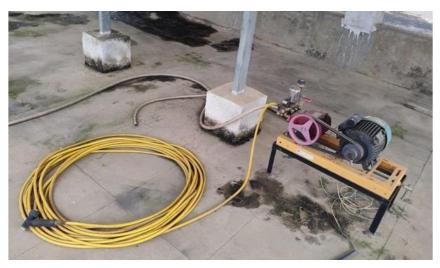
Figure 5-10 Pressurized water cleaning for SRTPV systems

The SRTPV system panels are well maintained and cleaned on regular basis. To remove the dust accumulated on the solar panel cells, pressurized water system is used for cleaning. The picture of the pressurized water cleaning system is given in figure 5.10.

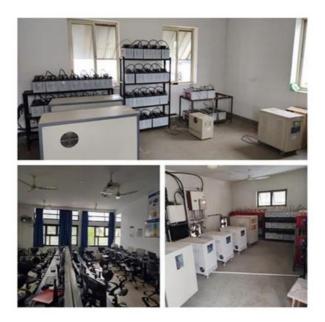
Figure 5-11: Well-ventilated and day-light integrated rooms

During the audit phase classrooms, Staff-rooms, computer lab, seminar hall, UPS & batteries room and library areas were surveyed for illumination levels and fresh aircirculation. It was observed most of the rooms are well ventilated and day-light integrated; sample photos are shown in figure 5-11 and figure 5-12.

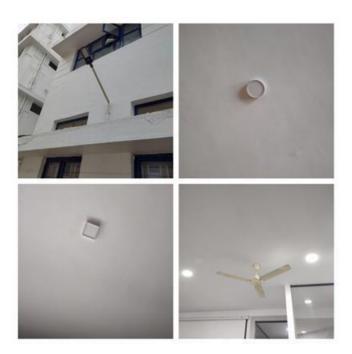
Figure 5-13: Use of LED lights

Many of the FTL in all the blocks of the campus are replaced with LED lights. LED tube lights are used in the class rooms, staff-rooms, corridors, hostel, dining area, building façade lighting and in the library area. Sample photo of LED lamp used in the some of the location of the college area are shown in figure 5-13.

S. No.	Description	Unit	Values
1	Rated Wattage of LED lamps installed	W	20
2	Quantity of LED lamps installed	Nos	2513
3	Rated wattage of lamps used earlier	W	40
4	Savings per lamp by installation of LED	W	
	lamps		20
5	Total savings	kW	50.26
6	Working hours per day	hours	8
7	No. of working days per year	days	250
8	Annual electricity savings	kWh	100520
9	Average electricity cost	Rs./kWh	9.73
10	Annual cost savings achieved per year	Rs. lakh/year	9.78
11	CO2 mitigations per year	Tons/year	85.44

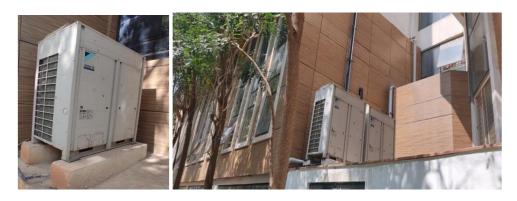
Figure 5-14: VRV Air Conditioning Unit

The conventional air cooled AC units are replaced with energy efficient VRV and Inverter type AC units. Purchase bills of energy efficient AC units are reviewed during the study and sample bill copy is given in figure 5-14 and figure 5-15.

S. No.	Description	Unit	Values
1	Rated Tonnage of AC units installed	TR	50
2	SEC of VRV AC units	kW/TR	1.2
3	SEC of Conventional air cooled AC units	kW/TR	1.8
4	Difference in SEC	kW/TR	0.6
5	Savings due to installation of VRV AC units	kW	30
6	Realizable savings @60%	kW	18
7	Working hours per day	hours	2
8	No. of working days per year	days	250
9	Annual electricity savings	kWh	9000
10	Average electricity cost	Rs./kWh	9.73
11	Annual cost savings achieved per year	Rs. lakh/year	0.88
12	CO2 mitigations per year	Tons/year	7.65

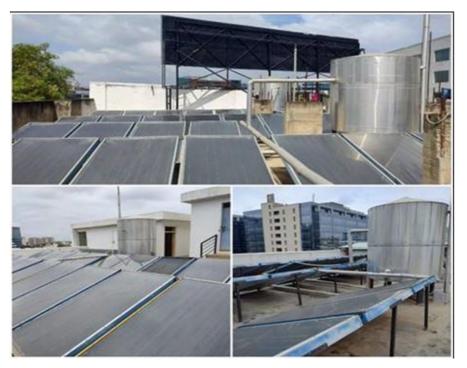
Figure 5-16: Use of Solar Water Heater

Solar water heaters are installed in boys and girls hostel for generating hot water. Sample photo of solar water heater used in the college area are shown in figure 5-16.

S. No.	Description	Unit	Values
1	Solar water heater installed	L	5000
2	Total amount of heat produced	kCal/hr	150000
3	Electricity equivalent	kWh	174.4186
4	No. of working days per year	days	250
5	Annual electricity savings	kWh	43604.65
6	Average electricity cost	Rs./kWh	9.73
7	Annual cost savings achieved per year	Rs. lakh/year	4.24
8	CO2 mitigations per year	Tons/year	37.06

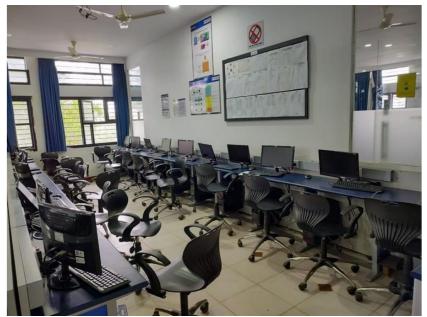
Figure 5-17: Use of LED monitors in the computer labs

LED/LCD monitors are used for all the desktop computers in staff rooms and in computer labs. Sample photos of the computer labs are as shown in the figure 5-17.

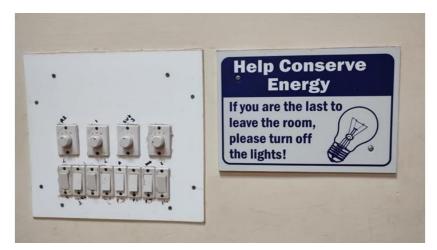
Figure 5-20: Sign boards to save energy

There were Sign boards stating 'Switch off the lights and fans when not in use' and 'Save Energy' posted in class rooms, staff-rooms, labs, libraries hostels and corridors. Sample picture taken during walk through is shown in the figure 5-20.
